Environmental Transmission of SARS at Amoy Gardens

Kelly R. McKinney, P.E.
Yu Yang Gong, Ph.D., P.E.
Thomas G. Lewis, P.E., J.D.

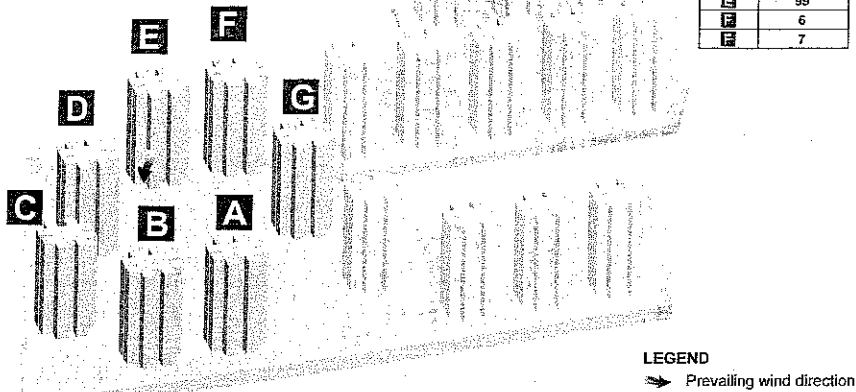
FIGURE 1

Amoy Gardens Complex, Kowloon Bay, Hong Kong

Distribution of Cases in Blocks A-G

Affected Block	Number of SARS Cases
A	4
B	21
C	25
D	20
E	99
F	6
G	7

LEGEND
 → Prevailing wind direction

Amoy Gardens is a private residential apartment complex with approximately 15,000 residents. The complex consists of 19 apartment towers, or blocks (Figure 1). Each block is a 33-story tower with eight apartments (of approximately 515 square feet each) on each floor. Recent studies suggest that the plumbing and ventilation systems at Amoy Gardens interacted to transmit the SARS CoV (Tilgner et al., 2003).

Significant initial exposures occurred in March 2003 in Block E bathrooms. The infection spread to other units in Block E by air movement between apartment units. Indeed, more than half the other patients with SARS (99 patients) lived in Block E. Yu and co-authors have confirmed through air modeling that the exhaust fans propelled virus-laden air into an outside air shaft, where it was carried upward by natural air currents and into other Block E apartments through open windows (Figure 5). The aerosols traveled upward on warm, humid air in the air shaft and entered apartments above and bordering the air shaft. After the plume reached the top of Block E, it was spread downstream to apartments in nearby buildings (blocks B, C, and D) by a predominant northeasterly wind. The warm,

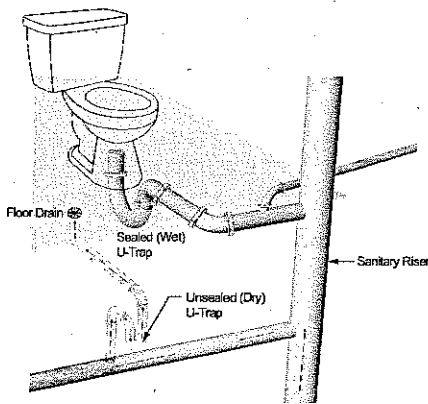
FIGURE 2

Typical Sanitary Plumbing Configuration

Sanitary plumbing for the towers consists of vertical drainage pipes (called sanitary risers, or stacks) connecting to bathrooms on every floor. The risers connect to sanitary fixtures (e.g., toilets, sinks, bathtubs, and floor drains, as illustrated in Figure 2), and each fixture is fitted with a U-shaped water trap (Figure 3). These traps (called U-traps or P-traps) are commonly used in building plumbing throughout the world to seal the connection between the fixture and the riser. They are designed to prevent sewer gases, insects, and rodents from entering the living space. They must be filled with water to function properly, however. Many traps in Block E were not sealed and provided a direct opening to the risers.

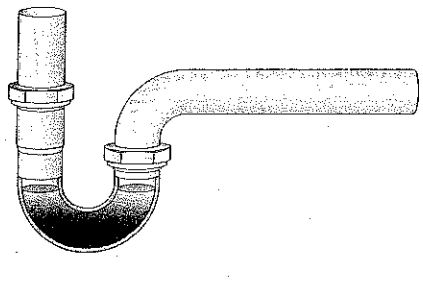
FIGURE 3

Typical U-Trap

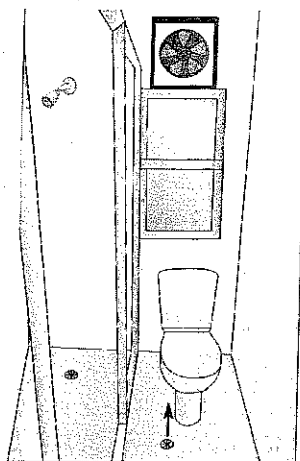
FIGURE 4**Typical Bathroom Configuration, Amoy Gardens**

A powerful fan installed in a small space creates significant negative pressure. With doors and windows closed, the fan draws air (called "make-up air") from any available source. The source of make-up air in this case was the sanitary riser connecting through the floor drains. The window-mounted fans created large pressure differentials that resulted in significant backflows into Block E bathrooms (Figure 4). The WHO environmental team verified, through odor detection and smoke tests, that sewer gas and aerosolized droplets were being drawn into the bathrooms from the plumbing system, with sewer gas velocity and droplet volume in direct proportion to fan power. In some bathrooms, air velocity inside the floor drain pipe approached 300 feet per minute, which,

according to WHO, was “sufficiently energetic to deliver large quantities of droplets into the washroom from infected stool passing in the waste pipe (Tilgner et al., 2003).

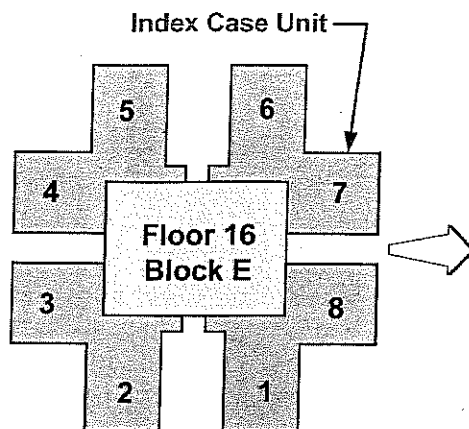
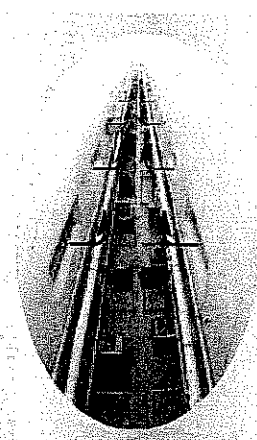
FIGURE 5**Index Case Unit and Open Airway**

High concentrations of SARS CoV were found in the feces and urine of the person with the index case. This person “shed” the virus through feces that were suspended in air, or aerosolized, by hydraulic action and filled the sanitary riser in Block E. Results of testing with a mockup of the Amoy Gardens piping system indicated that the hydraulic action caused by flushing toilets generated huge quantities of aerosols in sanitary risers (Yu et al., 2004).
